Mechanical Testing of Carbon Based Woven Thermal Protection Materials

John Pham¹, Parul Agrawal², James O. Arnold³, Keith Peterson² and Ethiraj Venkatapathy³

Objective

Assessment of the structural integrity of 3-D woven carbon cloths that have undergone heating similar to Venus atmospheric entry conditions.

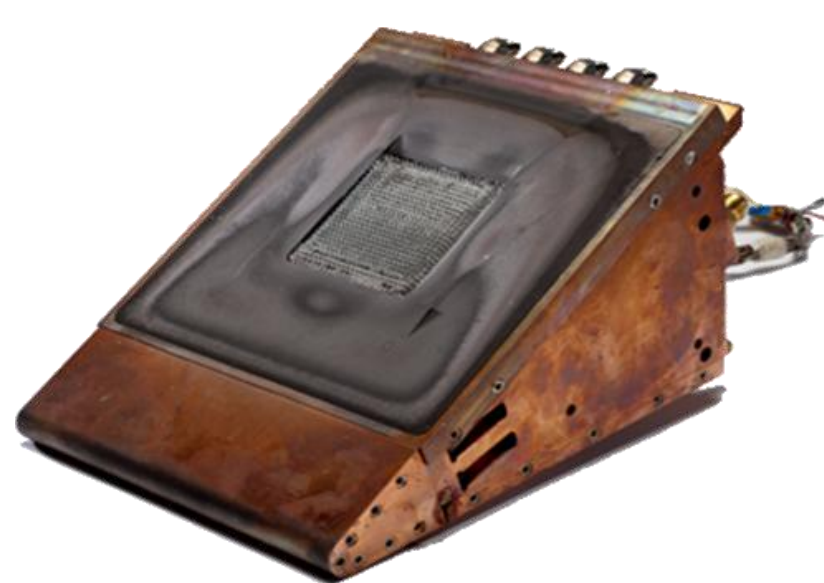
BLAM Testing

- Bi-axial load aerothermal mechanical (BLAM) testing
- Evaluate woven TPS under entry conditions

Model	Heat Flux on Fabric (W/cm ²)	Warp Running Load (N/cm)	Weft Running Load (N/cm)	Exposure Time (sec)
B1	136	1310	660	35
B2	97	660	330	135
B3	97	1310	660	139
